Manhole Inspection Summary

Manhole # S27I__050MH

Insp Date: **5/29/08 9:33 AM**

Location Address: **877 Hollins St**

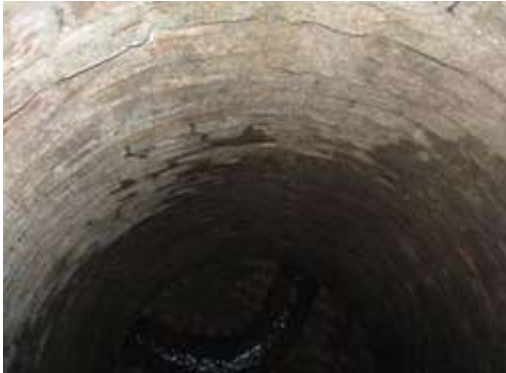
Defect 5

Infiltration: ☐ None ☐ Joint ☐ Cracks ☒ **Mortar** ☐ Roots ☒ **Wall**

barrel mortar, barrel flow wall

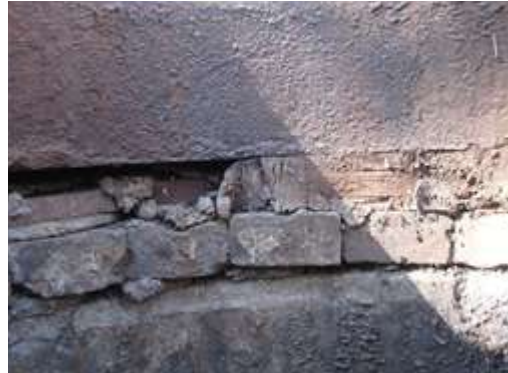
Defect 4

Condition: ☐ Sound ☒ **Cracked** ☐ Root Intrusion ☒ **Loose Brick** ☐ Deteriorated

Infiltration: ☐ None ☐ Joint ☒ **Cracks** ☐ Mortar ☐ Roots ☐ Wall

chimney cond cracked, cracks

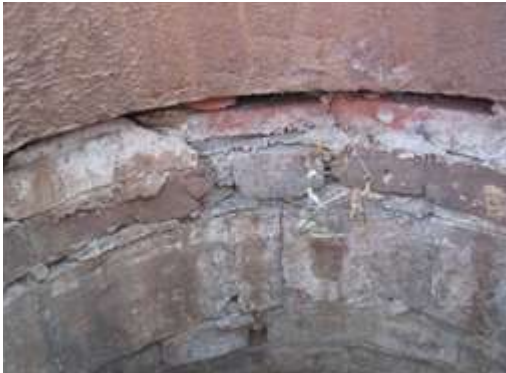
Defect 3

chimney cond loose bricks

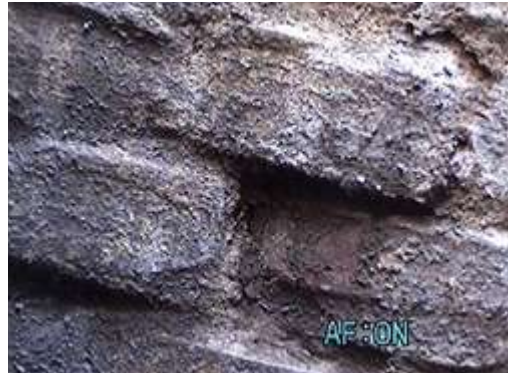
Defect 2

signs of infiltration corbel

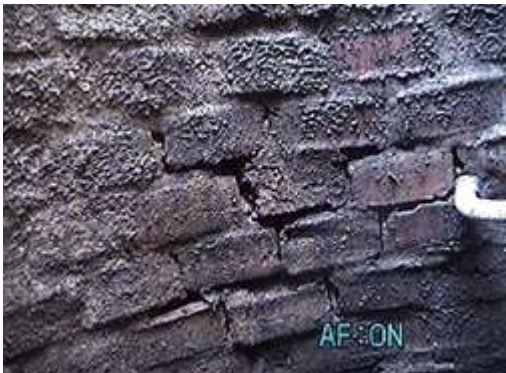
Defect 1

Condition: ☐ Sound ☒ **Cracked** ☐ Root Intrusion ☐ Loose Brick ☐ Deteriorated

Infiltration: ☐ None ☐ Joint ☐ Cracks ☒ **Mortar** ☐ Roots ☒ **Wall**

corbel cracked, corbel mortar, corbel flow wall

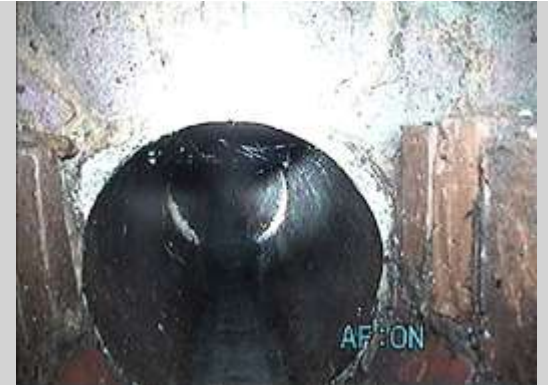
12 O'Clock Outflow

Pipe Height: **8.4** (in.) Rod and Bar (Angled)
Pipe Material: **Clay** ☐ Pipe Lined
Invert Depth: **9.71** (ft.) Flow Characteristics: **Slow**
Deposits: ☒ None ☐ Mud ☐ Sludge ☐ Debris ☐ Grease
Silt Depth: **0** (in.) Deposits Extent:
Infiltration: **None** Pipe Seal Cond: **Sound**

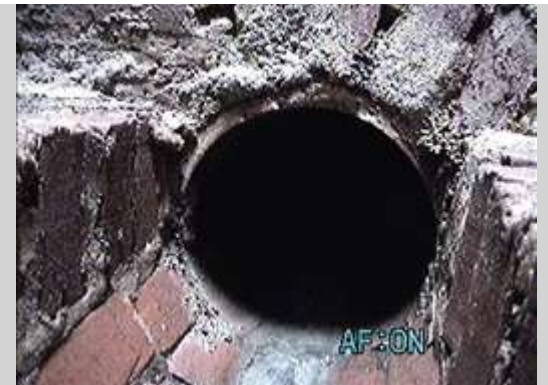
9 O'Clock Inflow

Pipe Height: **8.4** (in.) Rod and Bar (Angled)
Pipe Material: **Clay** ☐ Pipe Lined
Invert Depth: **9.64** (ft.) Flow Characteristics: **None**
Deposits: ☒ None ☐ Mud ☐ Sludge ☐ Debris ☐ Grease
Silt Depth: **0** (in.) Deposits Extent:
Infiltration: **None** Pipe Seal Cond: **Sound**
